**Crash scene investigation of heavy vehicles crash
: A Case Study of Songkhla Province
(Paper ID.SCS11-015)**

Prince of Songkla University

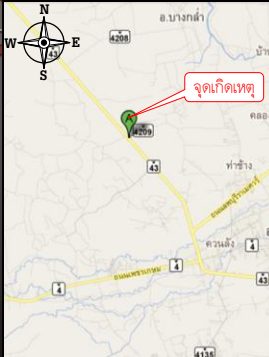
Location of the accident

- What : The bus driver doze off causing the accident
- Who: the bus driver has a broken leg and 21 passengers have a minor injuries
- when : Saturday, March 19, 2011 at 1:00 pm
- Where : National Highway No. 43 T.Ta-chang BangKlam district Songkhla Province

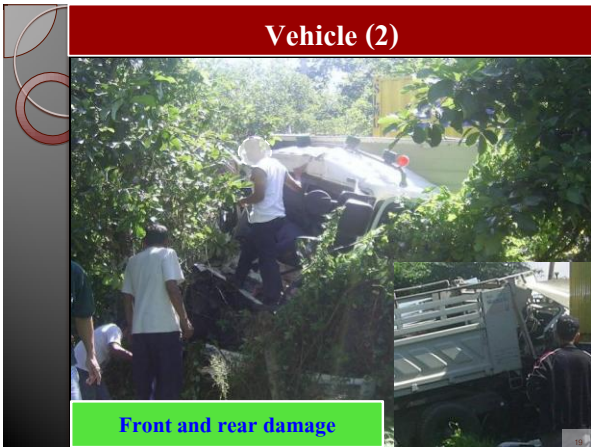
19

Front and rear damage

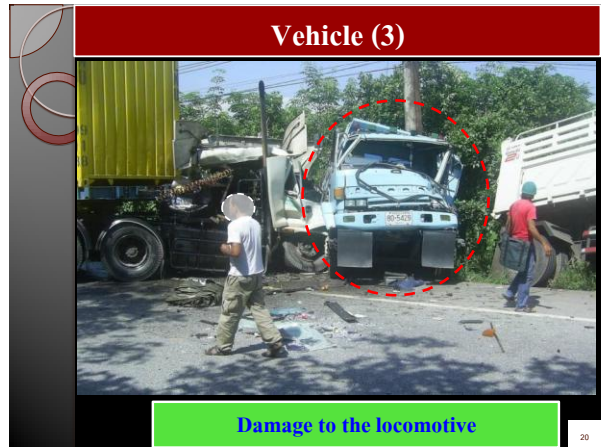
20

Damage to the locomotive
